Seismic Damage Analysis of Zamora Bridge in Ecuador

Abstract. The Zamora Bridge, located in the Zamora-Chinchi Province in the southeastern part of Ecuador, on the Pacific Rim seismic belt, serves as the sole river-crossing channel from the Mirador Copper Mine area to the exterior. Constructed and opened for traffic in 2013, this bridge is designed as a low-pier continuous girder bridge, featuring a three-span prestressed concrete continuous box girder for the main beam, with a span arrangement of 45.5+140+45.5 meters, and utilizes basin-type rubber bearings throughout. On May 6, 2019, and November 28, 2021, the Zamora Bridge experienced two significant seismic events. The initial seismic damage investigation revealed that the piers and foundation maintained their load-bearing capacity largely intact; the basin-type rubber bearings predominantly suffered shear failure and displacement, losing their horizontal limit capacity. Additionally, abutment blocks sheared, padstones cracked locally, and the main girder exhibited residual displacement. Following the first earthquake, repair work was undertaken based on the damage results, switching to friction pendulum seismic isolation bear

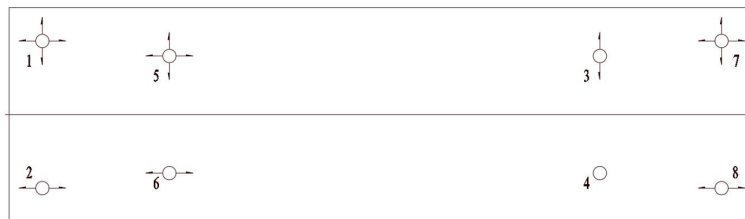
Fig. 2 Arrangement of basin-type rubber bearings

The earthquake damage investigation found that bearings and padstones are prone to damage under seismic action. Limited by the length of this article, only the vulnerability analysis of the bearings is conducted. Figure 2 shows the arrangement of basin-type rubber bearings. The relative displacement between the upper and lower ends of the bearing is used as the damage index, and the damage index thresholds for basin-type rubber bearings are obtained, as shown in Table 4 and 5.

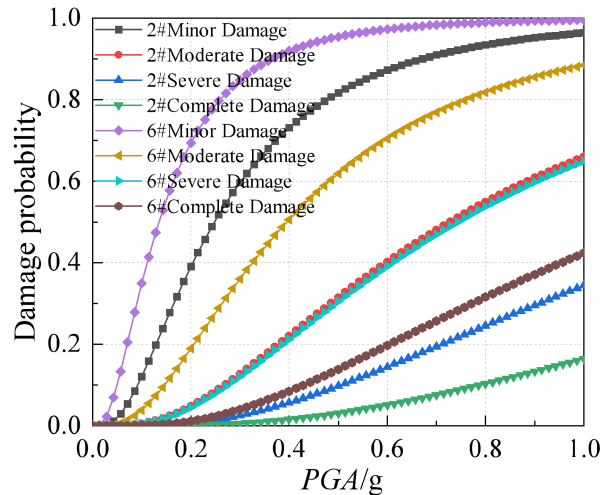
Fig. 3 Longitudinal seismic vulnerability curves of 2# and 6# basin rubber bearings

As shown in Figure 3, the damage exceedance probability of the basin-type rubber bearings increases with the intensity of seismic motion. The damage trends of bearings #2 and #6 are basically the same, but the damage exceedance probability of bearing #6 is greater than that of bearing #2. When the peak ground acceleration (PGA) is around 0.15g, the exceedance probability of minor damage for bearing #6 is 50%, and when the PGA is around 0.25g, the exceedance probability of minor damage for bearing #2 is 50%. At 1.0g, the probability of minor damage for both bearings is approaching 100%. The exceedance probability of severe damage for bearing #2 is around 35% at 1.0g, while for bearing #6, it is around 65%. The exceedance probability of complete damage for bearing #2 does not exceed 20% at 1.0g, while for bearing #6, it does not exceed 50%. It can be seen that when using basin-type rubber bearings, the probability of damage to the bearings under seismic action is relatively high, and it is necessary to replace them with isolation bearings to improve the seismic performance of the bridge.

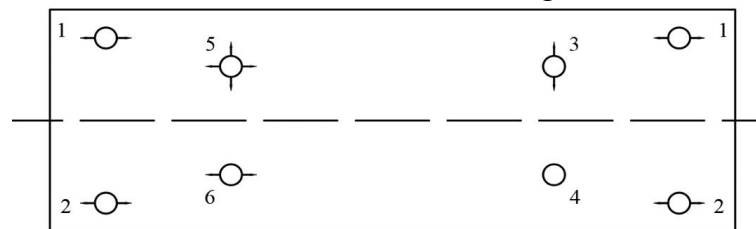
Fig. 4 Arrangement of friction pendulum bearings

Figure 4 shows the arrangement of friction pendulum bearings. The seismic design displacement D_d of the friction pendulum bearing is 200 mm, and the radius R is 4000mm. The design displacement of the bearing is used as the threshold value for minor damage, and $D_d/2=0.2R=800$ mm is used as the threshold value for complete damage. The damage states of the friction pendulum bearing are divided into five levels, with each level and its damage index shown in Table 6.

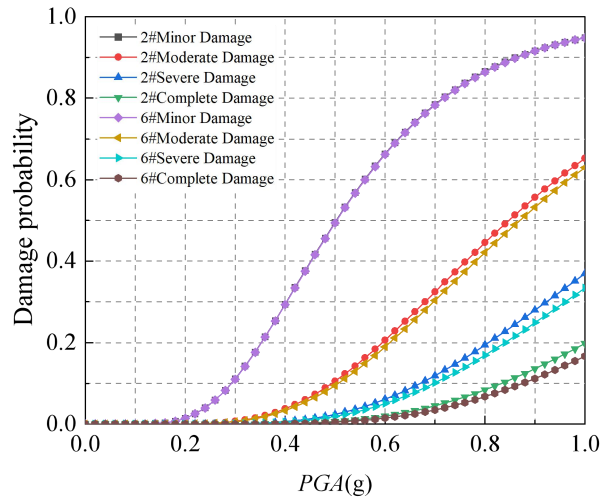
Fig. 5 Longitudinal seismic vulnerability curves of 2# and 6# friction pendulum bearings

From Figure 5, it can be seen that the vulnerability curves for minor damage to bearings #2 and #6 with friction pendulum bearings almost completely overlap, while for other degrees of damage, the probability of damage to bearing #2 is slightly greater than that of bearing #6. When the peak ground acceleration (PGA) is around 0.5g, the exceedance probability of minor damage for bearings #2 and #6 is around 50%, and at 1.0g, the probability of minor damage to the bearings is approaching 100%. The exceedance probability of severe damage to the bearings does not exceed 50% at 1.0g, and the exceedance probability of complete damage does not exceed 20% at 1.0g. The use of friction pendulum bearings has reduced the seismic response of the structure and significantly decreased the probability of damage to the bearings.
